Patriot Home Inspection, Inc.

CONFIDENTIAL INSPECTION REPORT

123 main st, Lockport, IL 60441

3/31/2010 2:00 pm to 5:00 pm

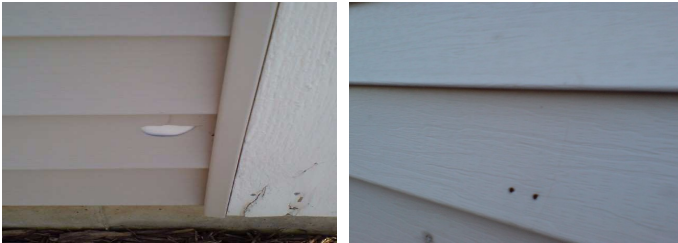
The vinyl siding is cracked. This can allow moisture and insects in which can cause rot. I would have the siding fixed by a qualified siding contractor.

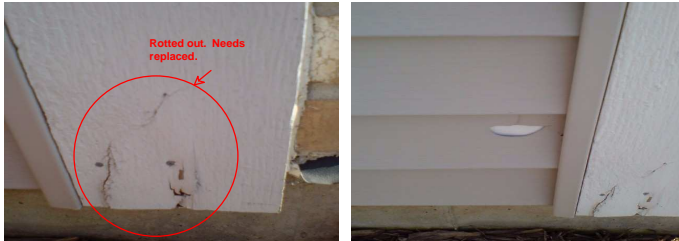
Sections of the fascia board or wood trim are weathered, and should be serviced to prevent further deterioration.

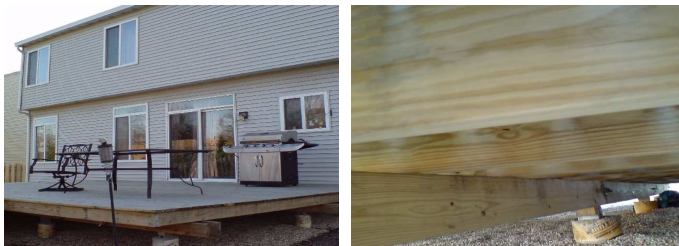
The wood deck is in acceptable condition, and should be maintained and periodically sealed.

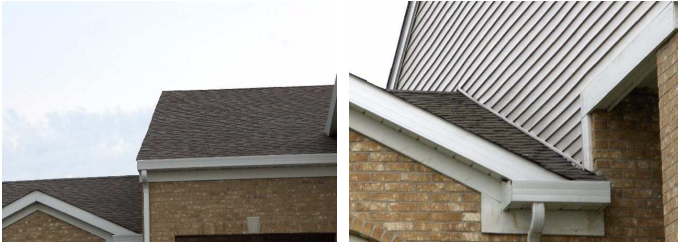
We evaluated the roof and its components by walking on its surface.

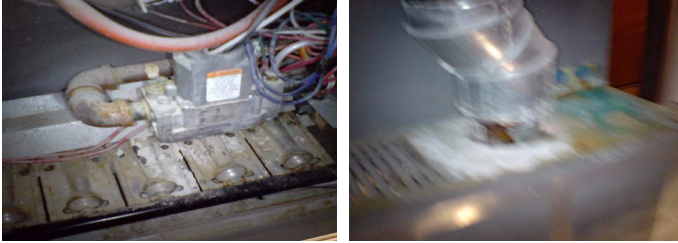
Rust particulates are accumulating below the burners in the combustion chamber of the gas furnace. They are typically caused by condensation, but should be removed before more particulates gather and smother the burners.

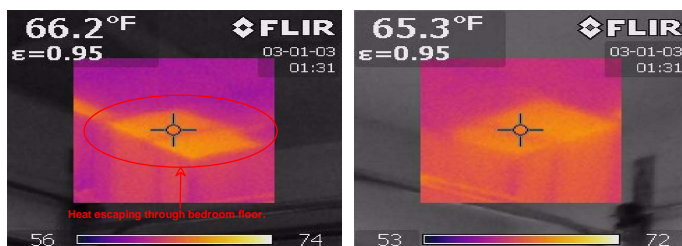
There is insulation missing in the garage ceiling which is the floor to bedroom three. This could lead to a moisture problem in the summer when warm outside air is cooled by the inside air and creates condensation. I recommend the insulation be fixed by a qualified insulation specialist.
